West Texas A&M University

Facility Condition Assessment

Panhandle Plains Historic Museum

March 14th, 2025

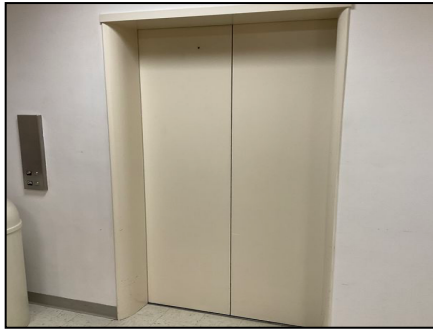
Conveying

The museum is equipped with three passenger elevators, each serving different sections of the facility. The elevator added in 1966 underwent updates to comply with the Americans with Disabilities Act in 2000, enhancing accessibility for all visitors. Meanwhile, the elevator in the Petroleum Wing was installed in 1982, and the annex elevator dates back to 1951. While all elevators are currently functional, they have exceeded their recommended useful life.

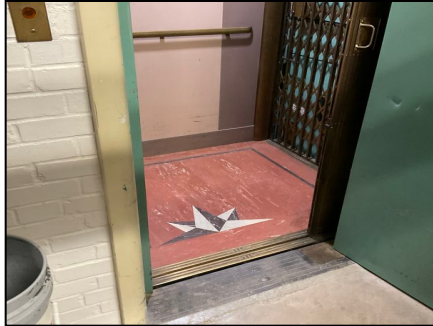
Conveying

The museum is equipped with two freight elevators, one of which was incorporated during the expansion in 1996, while the other was introduced in 1981 alongside the establishment of the Petroleum Wing. Although both elevators are currently functional they were observed to be in fair condition.

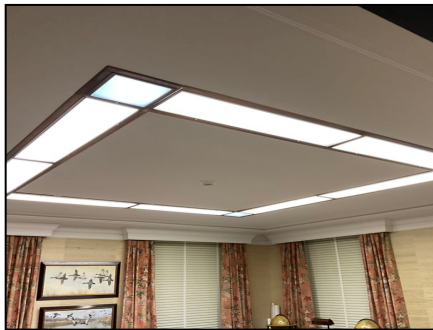
Electrical

Museum lighting was upgraded from incandescent, halogen, and fluorescent to LED between 2008 and 2010, retaining the original fixture types. The electrical branch wiring system is beyond its recommended life cycle.

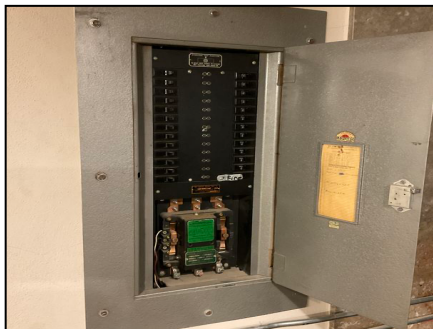
Electrical

In areas that have not undergone renovations since 2000, the majority of service panels, switchboards, panel boards, and cable infrastructure have surpassed their anticipated lifespan. A significant portion of this equipment has been noted to be quite aged and in a state of disrepair.

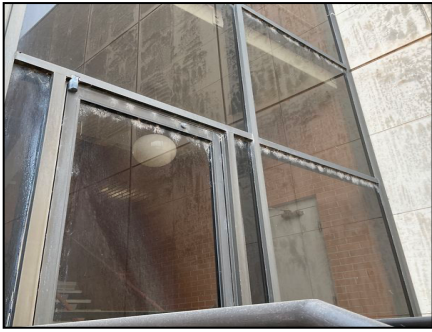
Exterior Enclosure

The exterior metal and glazed doors have surpassed their anticipated lifespan. The hardware associated with the metal doors has been noted to be in a deteriorating state, whereas the hardware for the glazed doors is in moderate condition and will require replacement or repair to ensure functionality. Although the overhead door is showing signs of aging, it remains operational.

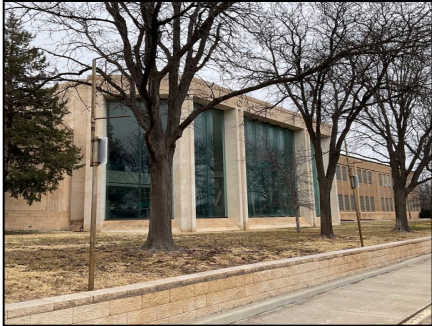
Exterior Enclosure

The curtain wall window system in the Petroleum Wing is currently in a moderate state of repair and is need of replacement have exceeded its recommended useful life.

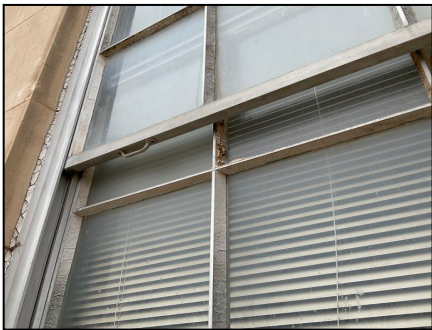
Exterior Enclosure

The exterior windows have exceeded their expected lifespan. Only a few have been updated, while most have remained unchanged since 1974. These windows are constructed from single-pane aluminum, which significantly lacks energy efficiency.

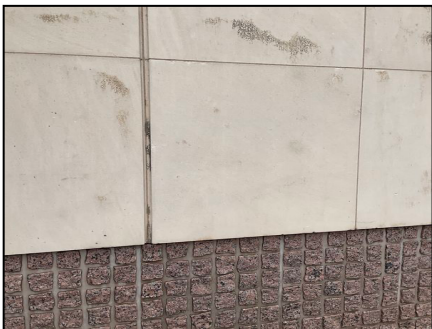
Exterior Enclosure

The exterior wall finishes were in fair condition. It was noted that many parapets require re-grouting or re-caulking, and there are signs of chipping in various areas. Additionally, the expansion joints at the connections between buildings are in need of repair.

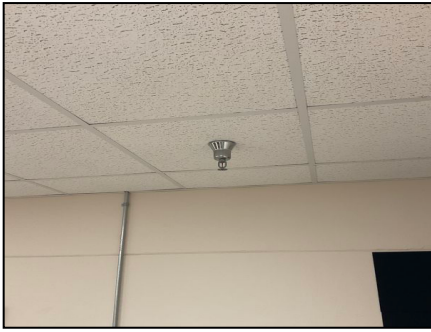
Fire Protection

The facility sprinkler system is outdated, and a chemical system must be updated to best protect historical artifacts within the facility.

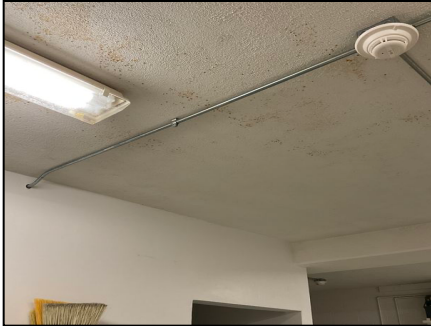
Fire Protection

In sections of the facility that were not renovated in 2000, the wiring for the fire alarm system has surpassed its anticipated lifespan. Additionally, the State's Fire Marshal Office conducted an inspection report on 01/14/25. 149 violations were notated of mixed severity. Violations included, but not limited to, no evacuation diagrams noted to be present in the building – multiple areas throughout the ceiling on all levels with exposed wiring in old junction boxes – partial sprinkler system in the Basement and 1st Level. The entire building is required to be sprinklered. Based on these findings and the exceeded life cycle the fire alarm and protection system is noted to be in poor condition.

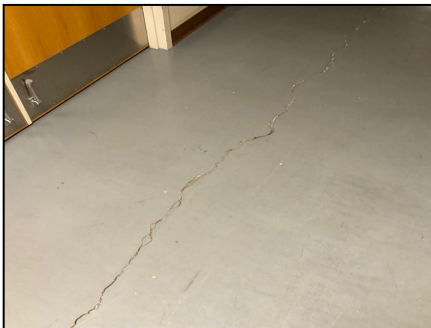
Interiors

Vinyl composition tile (VCT) flooring has surpassed its anticipated lifespan, constituting roughly 41% of the total flooring, with 65% of that being 9" x 9" tiles. All carpeting has also exceeded its expected lifespan, particularly in the older library, where it appears to be adhered to the underlying 9" x 9" tiles, exhibiting visible damage in the office areas on the second and third floors. The carpeting in display areas is showing significant signs of wear and tear, while a small section of carpet squares installed last year remains in good condition. The stone, wood, and laminate flooring in the display areas on the second floor are all in fair to poor condition.

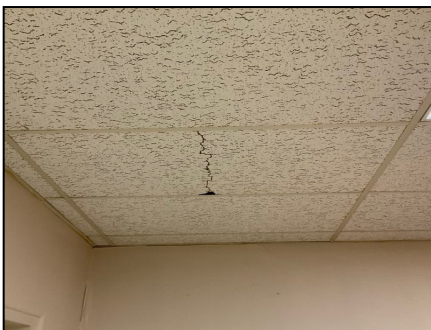
Interiors

In sections that have not undergone renovation since 2000, the acoustic ceilings are observed to be in fair to poor condition, with numerous tiles exhibiting cracks that necessitate replacement. Additionally, several areas show signs of staining due to leaks from the roof or piping, and there are instances of sagging tiles within the grid system.

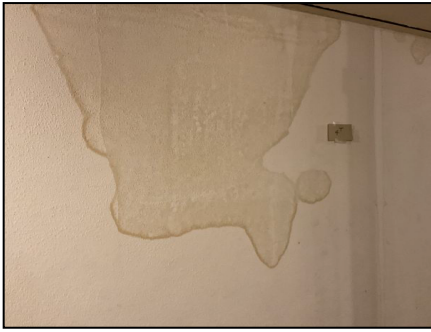
Interiors

The wall structure predominantly consists of gypsum and has been noted to exhibit numerous instances of cracking and deterioration. It is recommended that these walls be repaired and repainted to restore their integrity. Additionally, the wall coverings applied in certain areas of the basement and second floor are experiencing significant failure, as evidenced by visible peeling and blistering in multiple locations.

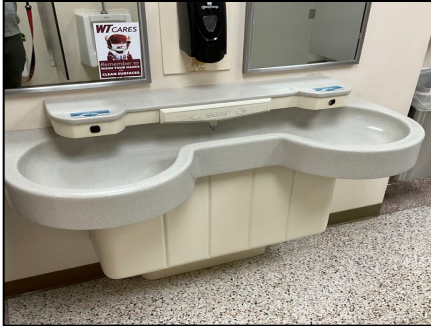
Plumbing

In areas that were not updated in 2000, the plumbing fixtures are still functional; however, they have surpassed their anticipated lifespan. In the areas that underwent renovations in 2000, the plumbing fixtures remain in good condition.

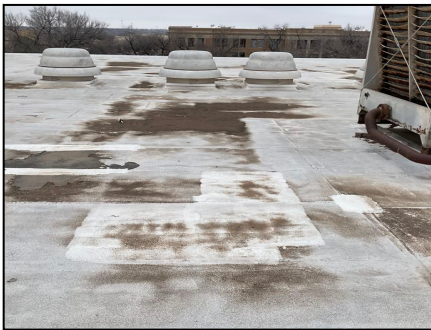
Roofing

The roofing system seems to be an older installation, with around half of the surface recently treated with a white mastic coating. Throughout the roof, several soft spots have been observed, indicating potential weaknesses. Additionally, water ponding presents a concern, as the roof lacks adequate slope towards the drainage points in multiple areas.

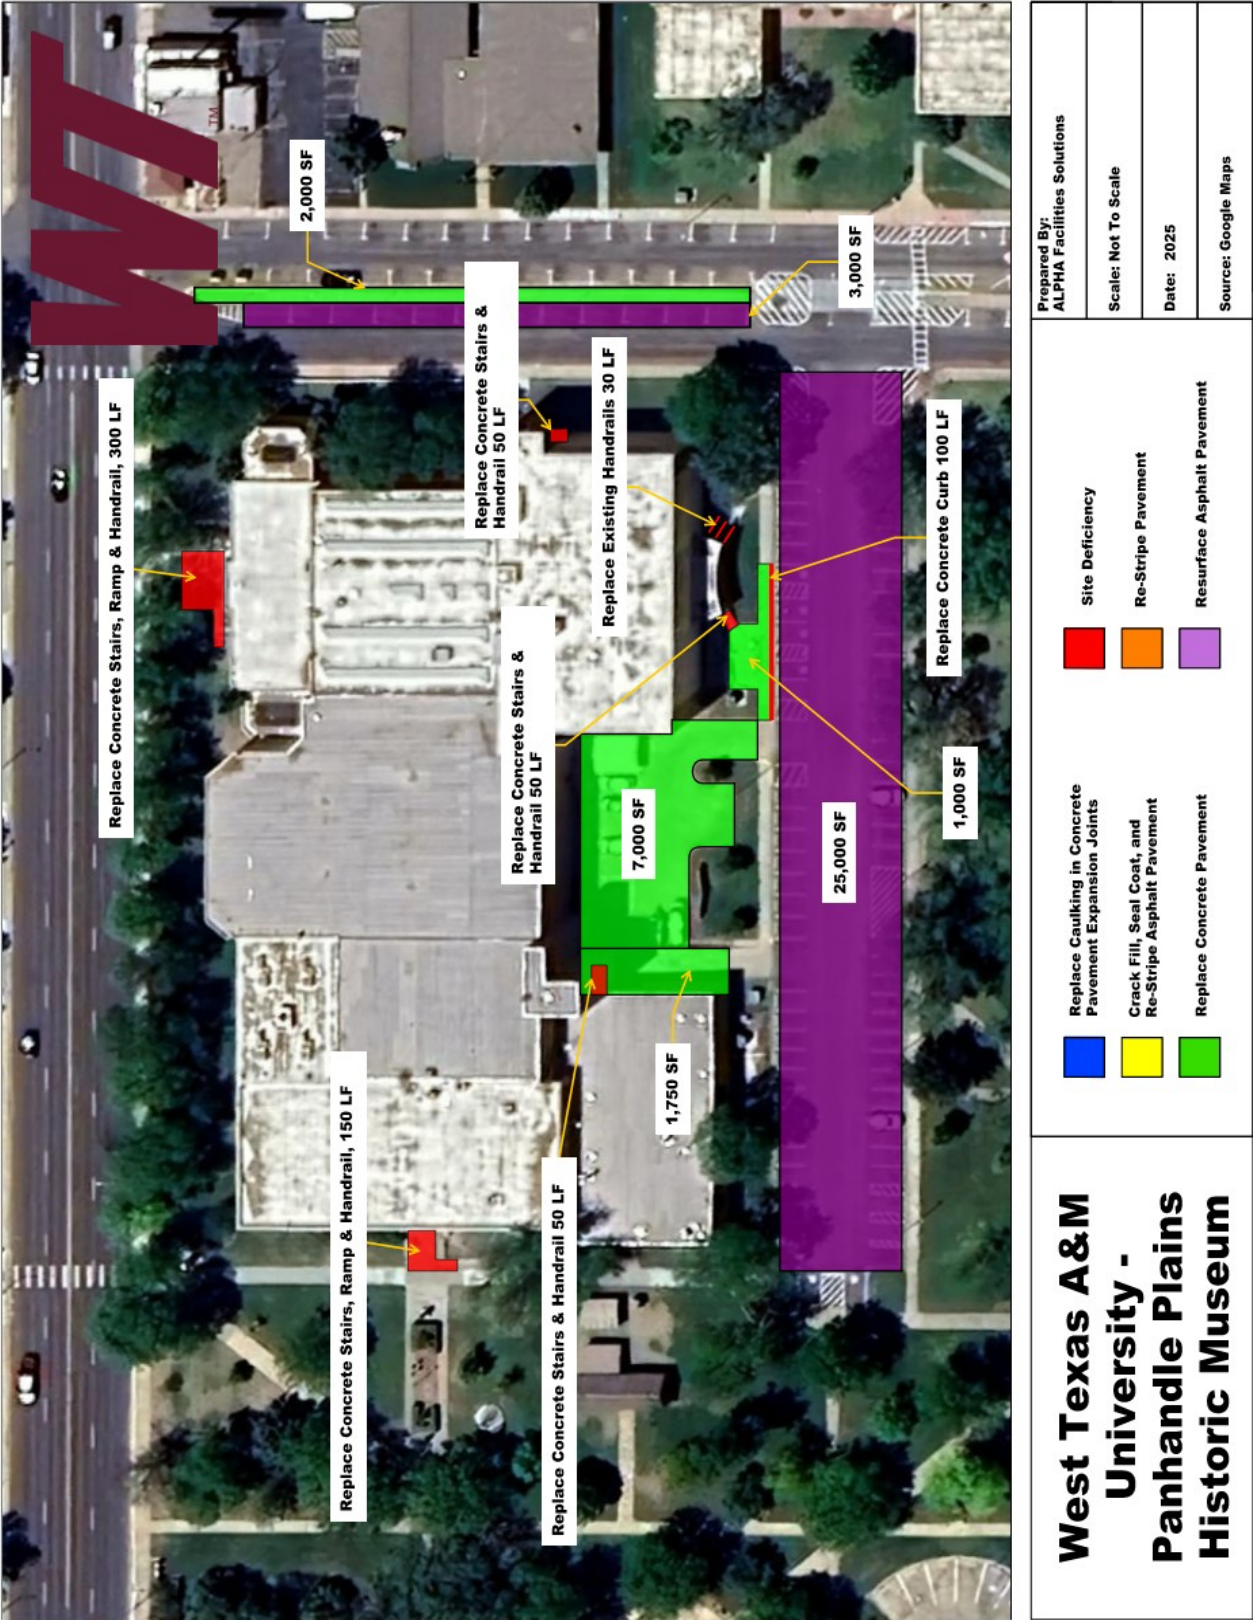
Figure 6. Site and Infrastructure Deficiencies Markup: Panhandle Plains Historic Museum

Asset Description	Corrective Action	Notes	Priority	Current Needs	Year
Pedestrian Pavements	Replace Concrete Pavements; 4" Thick	11750 SF @ \$11 Per SF	Low	\$129,250	2025
Site Development	Replace Concrete Stairs	600 LF @ \$160 Per LF	Low	\$96,000	2025
Site Development	Replace Existing Handrail	215 LF @ \$26 Per LF	Low	\$5,590	2025
Vehicular Pavements	Resurface Asphalt Pavements	28000 SF @ \$3.5 Per SF	Low	\$98,000	2025
Vehicular Pavements	Replace Concrete Curb	100 LF @ \$35 Per LF	Low	\$3,500	2025
			Total 2025 Needs	\$332,340

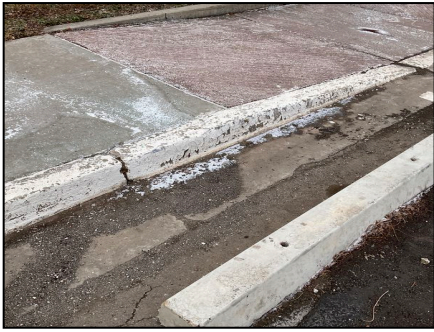
Site Infrastructure

A portion of the concrete curbing was in poor condition and in need of replacement as areas of broken, damaged, and/or heaving curbing was observed.

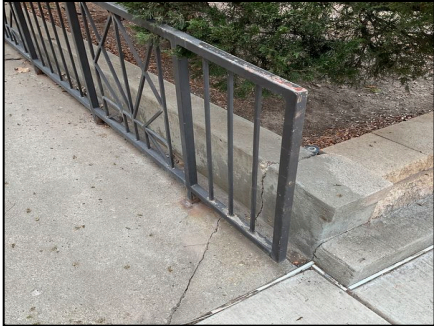
Site Infrastructure

A portion of the handrails were in poor condition and in need of replacement as rusted railing was observed.

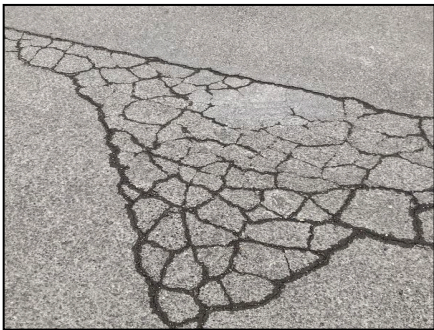
Site Infrastructure

A portion of the asphalt pavements were in poor condition and in need of resurfacing as longitudinal cracking, transverse cracking, and degradation were observed throughout the pavement.

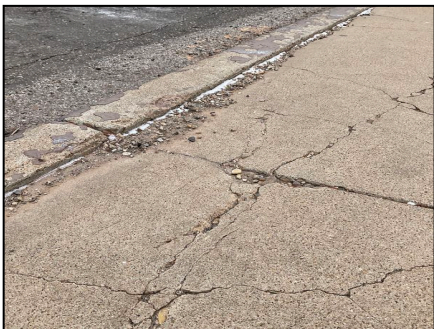
Site Infrastructure

A portion of the concrete sidewalks were in poor condition and in need of replacement as multiple areas of broken, damaged, and/or heaving pavement were observed.

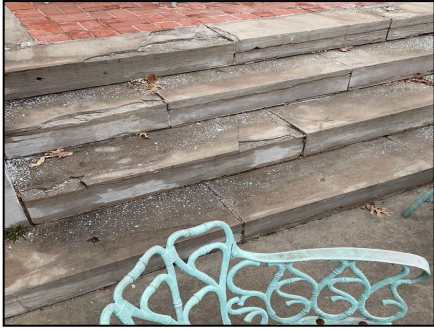
Site Infrastructure

A portion of the concrete stairs were in poor condition and in need of replacement as areas of broken, damaged and/or heaving steps were observed.

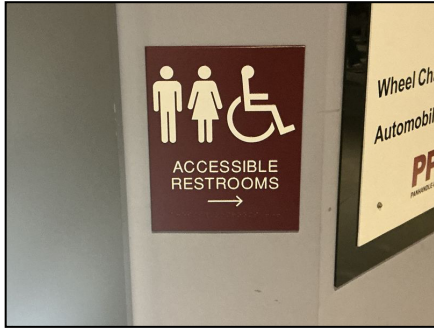
Accessibility

Accessible toilet rooms must be on an accessible route, identified with the International Symbol of Accessibility (ISA) featuring raised and Braille lettering, centered on an 18" x 18" clear floor space beyond the door swing, mounted 48"–60" above the floor.

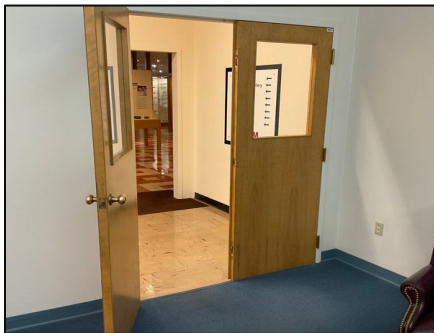
Accessibility

Corridor doors must be less than 32" wide with lever/loop hardware (no grasping/pinching/twisting) at 34"–48" height.

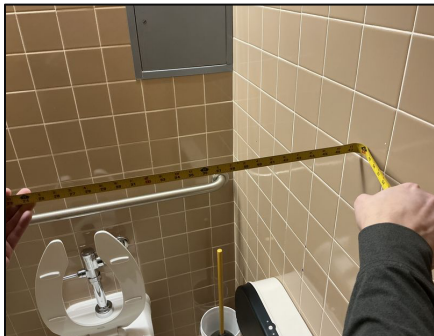
Accessibility

Toilet rooms require audible/visual fire alarms. Toilet stalls need wheelchair-accessible doors (less than 32" wide), grab bars on back and side walls, a toilet centerline 16"–18" from the side, and 60" x 56" clear area.

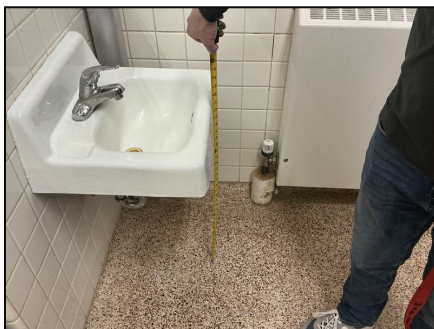
Accessibility

Sinks must have 27" wheelchair clearance, one-hand operable handles (no grasping/pinching/twisting), and insulated exposed pipes. Hire an architect-engineering firm to scope work and estimate costs. Install: pull handle, audible/visual fire alarm, 36" phenolic partition door, 42" side grab bar, accessible lavatory with compliant faucet, piping insulation, and new water closet. Demolish and replace wood door/frame. Reinstall/replace ISA sign per ADA standards.

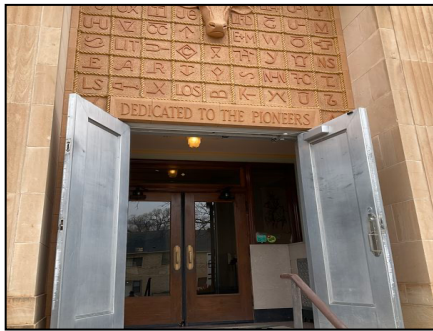
Accessibility

When the main entrance is inaccessible, there must be an alternate accessible entrance. The accessible entrance must be identified with the International Symbol of Accessibility. Hire architect-engineering firm to determine scope of work and estimate of costs. Install ADA sticker on door.

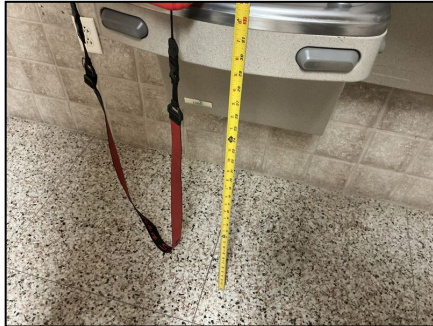
Accessibility

Accessible drinking fountains must be present. The area under drinking fountains must be no less than 17" but no greater than 25" deep. The operable parts of drinking fountains must be no higher than 44" above the floor. The operable parts of drinking fountains must be usable with one hand without pinching, grasping, or twisting of the wrist. The spout outlet of drinking fountains must be no higher than 36" above the floor. The spout outlet of drinking fountains must be at least 15" from the rear and no more than 5" from the front of the drinking fountain. Demolition of existing fountain. Install dual level drinking fountain.

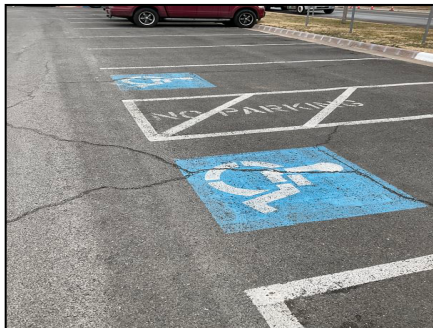
Accessibility

Sufficient van accessible parking spaces must be provided with respect to the total number of accessible spaces. Accessible van parking spaces must be at least 8' wide with an access aisle of at least 8' wide. Accessible spaces must be marked with the International Symbol of Accessibility, and van spaces must have signs reading 'Van Accessible'. Install pavement markings for parking space. Demo access aisle pavement markings. Install accessible parking signs with post.

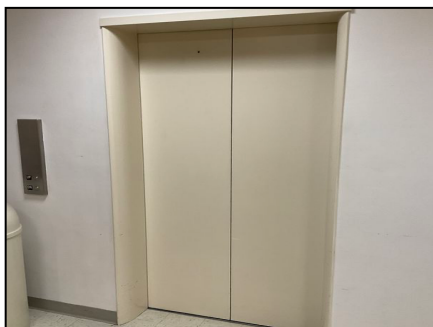
Accessibility

Elevator lobbies must have visual and audible indicators of car arrival. Standard raised and Braille markings must be present on both jambs of each hoist way entrance. Elevator doors must have a reopening device that will stop and reopen a car door if an object or a person obstructs the door. Where a clear floor or ground space allows an unobstructed parallel or forward approach, the elevator buttons must be at least 15" and less than 48" above the ground. A two-way emergency communication system within the elevator cab must be usable without voice communication. Install braille door jamb markings. Install a new infrared entrance door sensor. Install hall lanterns with audible and visual capabilities. Replace hallway call buttons. Install ADA compliant two way communication device.
