FIRE & LIFE SAFETY STUDY

BUFFALO COURTS • PANHANDLE-PLAINS HISTORICAL MUSEUM
MARY MOODY NORTHERN HALL • SYBIL B. HARRINGTON FINE ARTS COMPLEX
VIRGIL HENSON ACTIVITIES CENTER

February 16, 2017

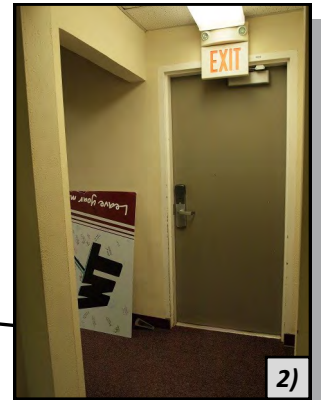
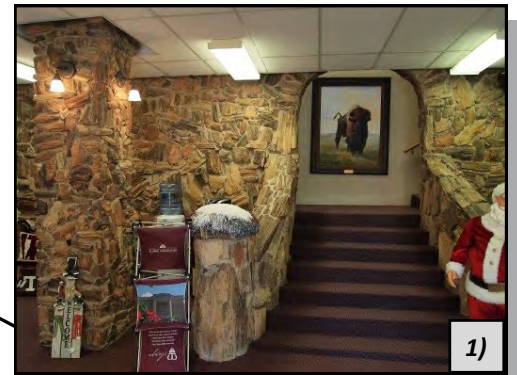
- 1) "The front stairway is unenclosed and not protected.".....(39.2.2.3.1, 7.2.2.5.1.1, 7.2.2.5.2.1, 7.1.3.2 and 8.2)
- 2) "Both stairways discharge into the interior of the building."(39.2.7 and 7.7.2)
- 3) "The front stairway is unenclosed creating a vertical opening.".....(39.3.1.1 and 8.6)

Proposed new frame and door in the hall adjacent to the back stair to provide a direct exit from that stair to the exterior.

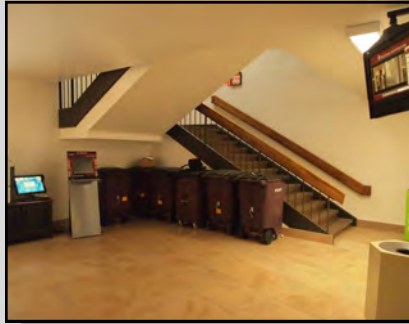
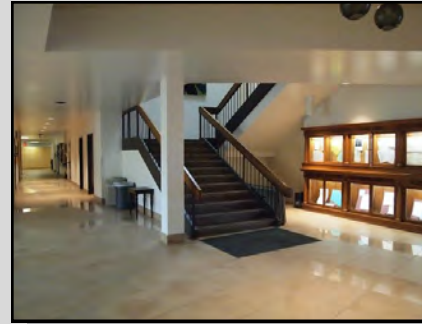
1) "All 3 stairways are unenclosed and not protected." (39.2.2.3.1, 7.2.2.5.1.1, 7.2.2.5.2.1, 7.1.3.2 and 8.2)

CORRECTIVE ACTION:
Remove the existing southwest stairs between the first and second floors. Provide a new stair tower at the southwest corner and rework the existing southeast stair to exit to the exterior.

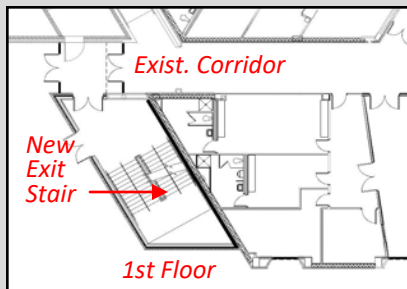
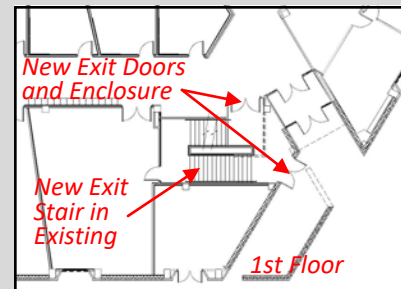
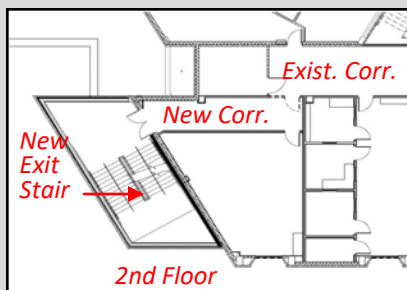
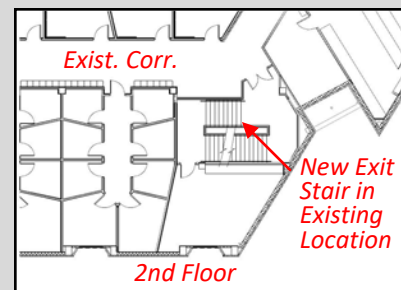
2) "All 3 stairways discharge into the interior of the building." (39.2.7 and 7.7.2)

CORRECTIVE ACTION: . After addition of the new stair tower and revising the southeast stair, two of the three stairs will exit to the exterior.

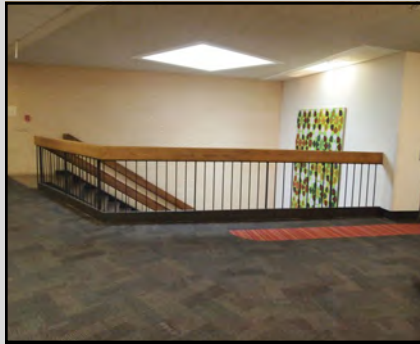
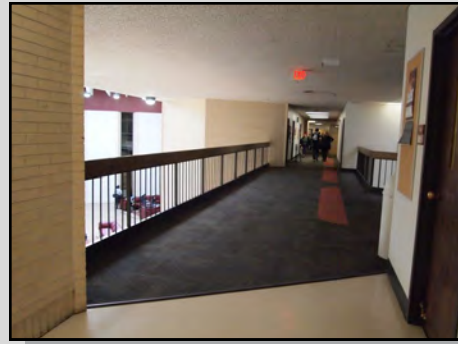
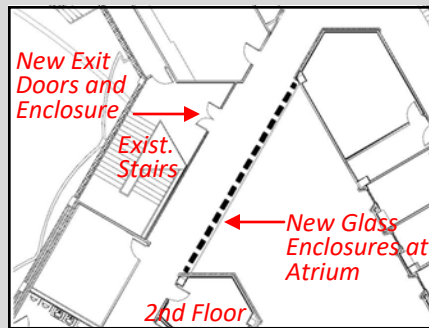
3) "All 3 three stairways are unenclosed creating vertical openings." (39.3.1.1 and 8.6)

CORRECTIVE ACTION: . . .The upper portion of the remaining interior stair will be separated from the rest of the story with a smoke barrier. The atrium will be separated from the second floor level with full height glass enclosures at the open sides.

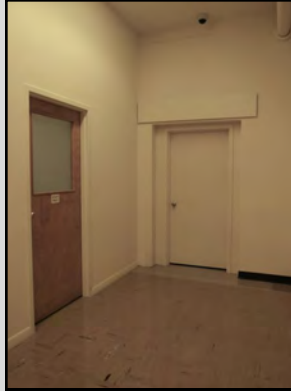
- 1) "The door providing separation between the assembly and storage areas on the 2nd floor lacks the required 1½ hour fire-rating and the 2 doors providing separation between the industrial occupancy woodshop and storage area in the basement lacks the required 3/4 hour fire-rating."(13.1.3.1, 40.1.3, 42.1.3, 6.1.14.4 and 8.3.4.2)

CORRECTIVE ACTION: Provide new doors with the required fire rating in both locations.

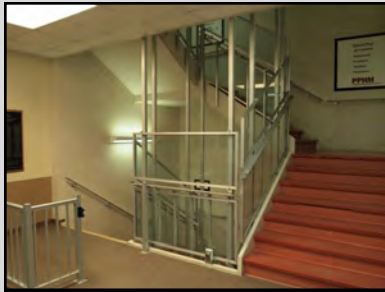
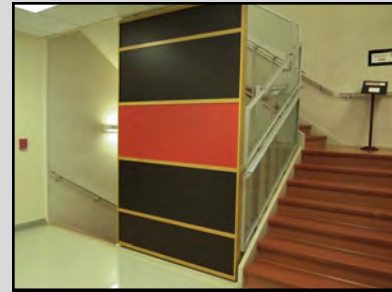
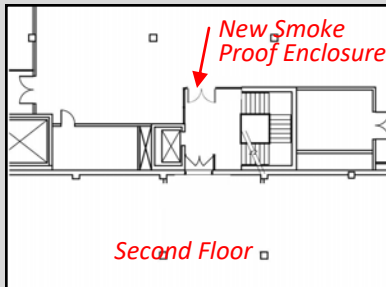
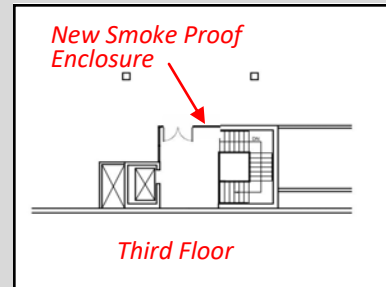
- 2) "The center stair is unenclosed and not protected on the 2nd and 3rd floors."
..... (13.2.2.3.1, 7.2.2.5.1.1, 7.2.2.5.1.2, 7.1.3.2 and 8.2)

CORRECTIVE ACTION: Provide enclosures for the stair at the second and third floors.

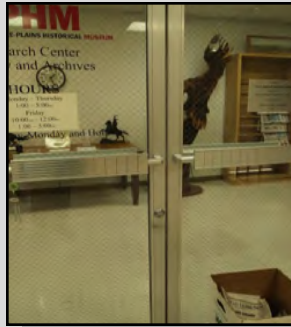
5) "There is an unapproved key operated locking device on the center stair door on the 3rd floor.
..... (13.2.2.2.1, 7.2.1.5.1 and 7.2.1.5.3)

CORRECTIVE ACTION: Replace existing locking device with compliant hardware.

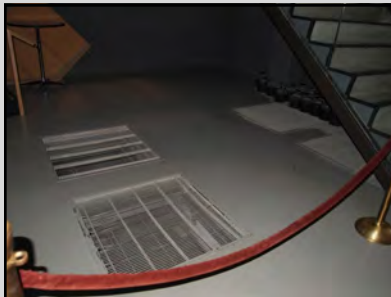
8) "There is a vertical penetration through the ceiling extending in to the first floor adjacent to room W010A."
..... (8.4.4.1 and 8.5.6.2)

CORRECTIVE ACTION: Close vertical penetration with fire dampers.

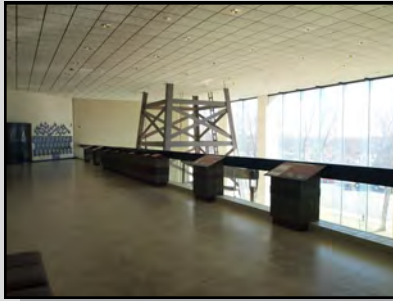
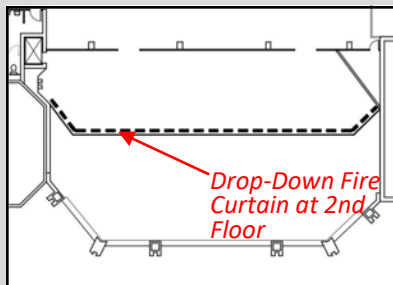
- 9) "There is no separation of the remainder of the building from the communicating space by a 1 hour fire barrier." (13.3.1 and 8.6.6(4))

CORRECTIVE ACTION: Provide a drop-down fire curtain at the second floor level.

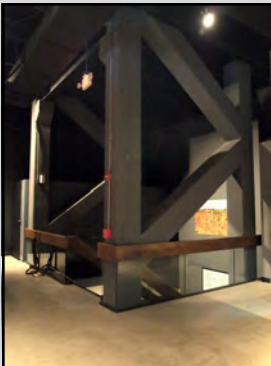
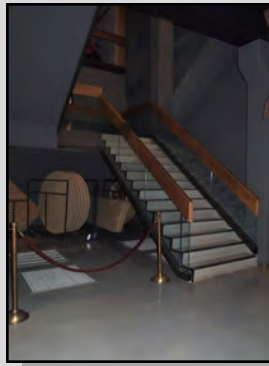
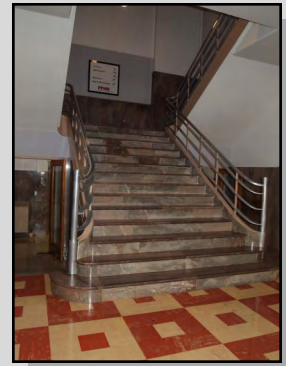
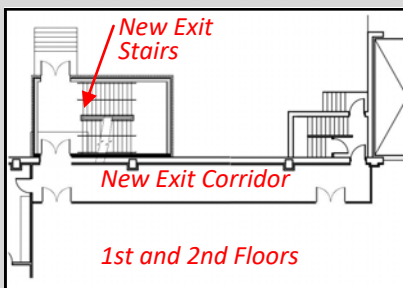
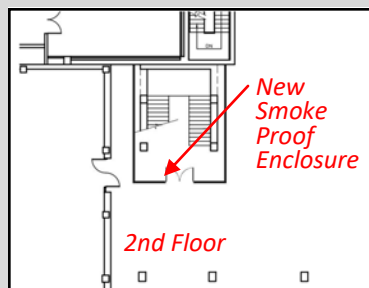
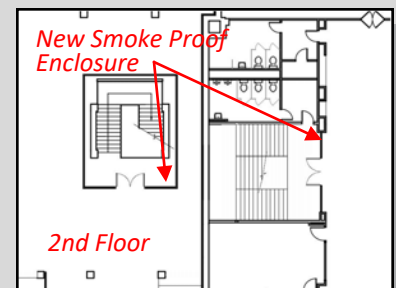
- 10) "The 4 convenience stairs are not separated from the corridors and the building is not protected throughout by a fire sprinkler system." (13.3.1, 8.6.9.1(3), 8.6.9.2(2) and 9.7)

CORRECTIVE ACTION: Provide a fire sprinkler system. Provide new exit corridors on the first and second floors. Provide smoke proof enclosures at convenience stairs at the second floor.

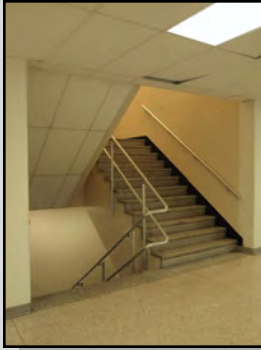
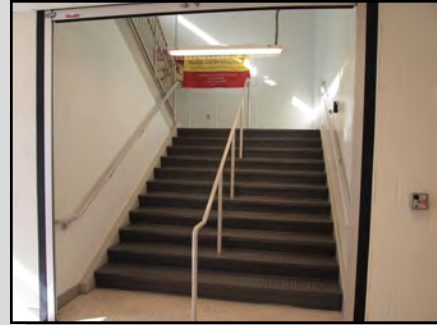
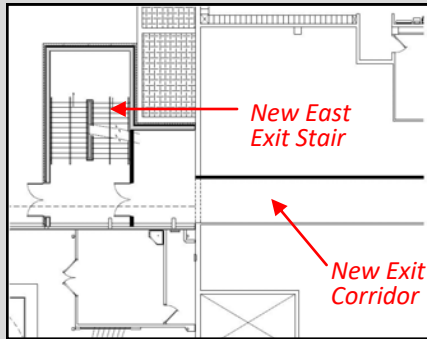
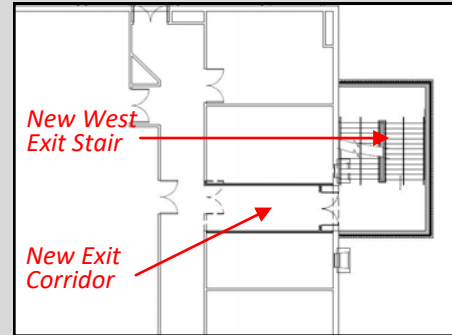
- 1) "Only 1 stair out of 5 discharges directly to the exterior of the building." (13.2.7.1 and 7.7.2)

CORRECTIVE ACTION: Provide two new stair towers on the east and west sides of the building, and rework the existing south stair to exit to the exterior. This will provide four out of five stairs to discharge directly to the exterior.

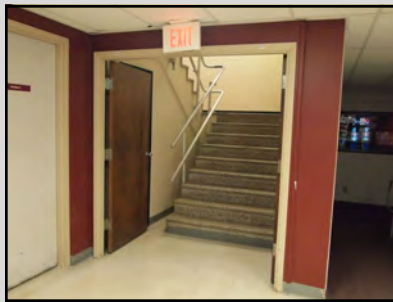
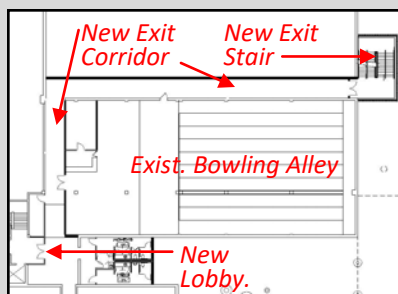
- 2) "The 2 basement stair doors adjacent to the bowling alley lack a 1 hour fire-rating resulting in a lack of stair enclosure." (13.2.2.3.1, 7.2.2.5.1.1, 7.1.3.2.1(1), 8.2.2.2 and 8.3.4.2)

CORRECTIVE ACTION: Provide a new rated stair and elevator lobby in the basement and provide a new exit corridor in the basement leading to the new west exit stair.

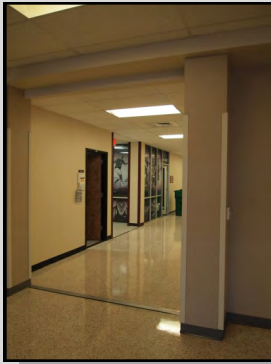
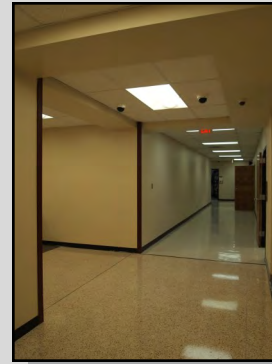
3) "There is a lack of exit signs adjacent to rooms 207, 219 and exit from swimming pool." (13.2.10 and 7.10)

CORRECTIVE ACTION: Provide additional exit signage at locations indicated in the Fire Marshall's report.

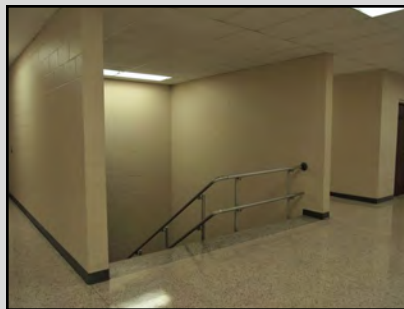
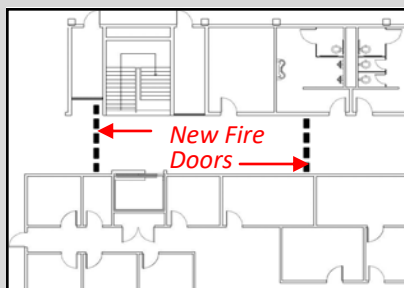
6) "The 2 center convenience stairs are not separated from the corridors and the building is not protected throughout by a fire sprinkler system." (13.3.1, 8.6.9.1(3), 8.6.9.2(2) and 9.7)

CORRECTIVE ACTION: A) Provide full sprinkler system. B) Install fire separation doors on the second floor to separate the existing stairs and elevator from the first floor.
